PROPERTY INSPECTION REPORT

Sample - Commercial Inspection, Photo distorted on purpose TN, 37363
Inspection prepared for: Commercial Inspection
Inspection Date: 2/27/2011 Time: 1:00 PM
Age: Built 1995 Size: 7500 sqft
Weather: Partly Cloudy

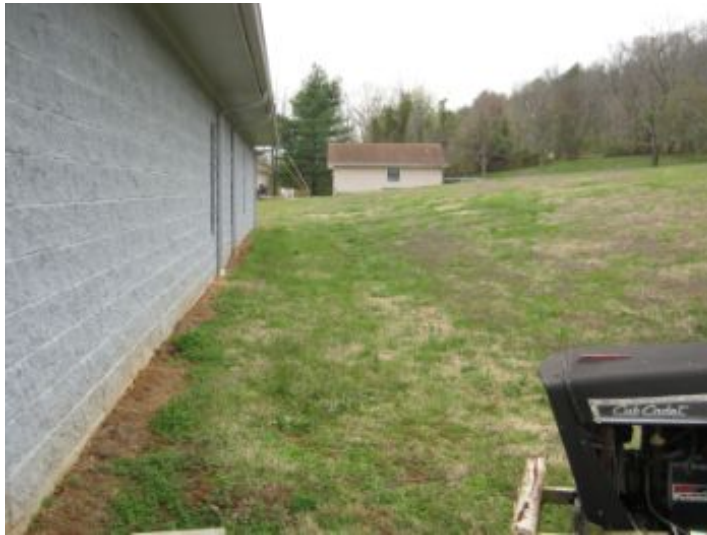
Negative Drainage - Drainage is negative, which means water will flow toward the structure. In order to correct this condition, it may be necessary to regrade by lowering or raising the immediate grade to divert water away from the building a minimum of ten feet. MONITOR area during rains budgeting appropriate corrections as needed.

Rear Negative Drainage - Drainage is negative, which means water will flow toward the structure. In order to correct this condition, it may be necessary to regrade by lowering or raising the immediate grade to divert water away from the building a minimum of ten feet. MONITOR area during rains budgeting appropriate corrections as needed.

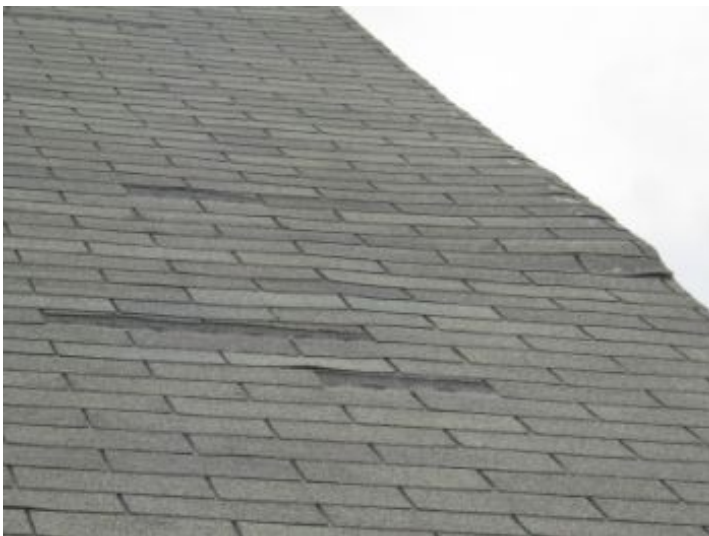
Representative roofing damage photo

Consider premature replacement - Weigh your options for repairing roofing now knowing that you should replace it in the near future with the option of proper complete replacement now. Considering that a properly replaced roofing system may last up to three decades it may make better sense to replace the roofing correctly now rather than to repair an older roof system that will have to be replaced soon anyway.

Roofing is ready for periodic maintenance. Have a qualified competent contractor check entire roof system and associated flashings. Repair or replace affected areas as needed.

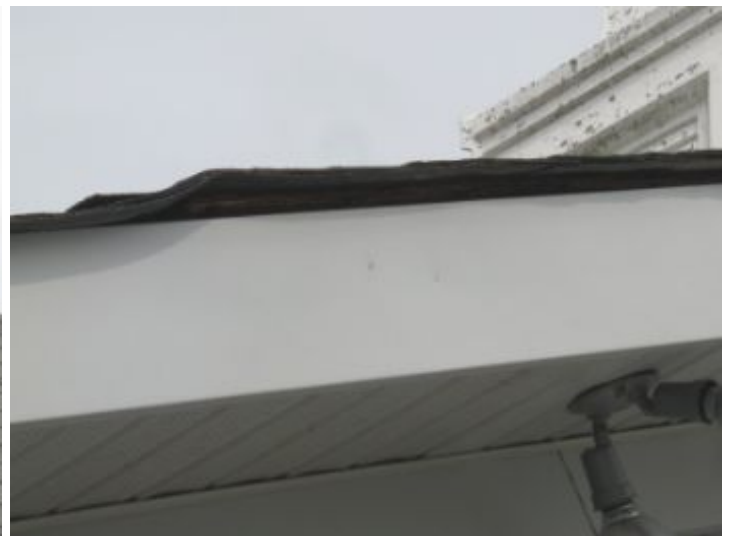
Some decking lifted

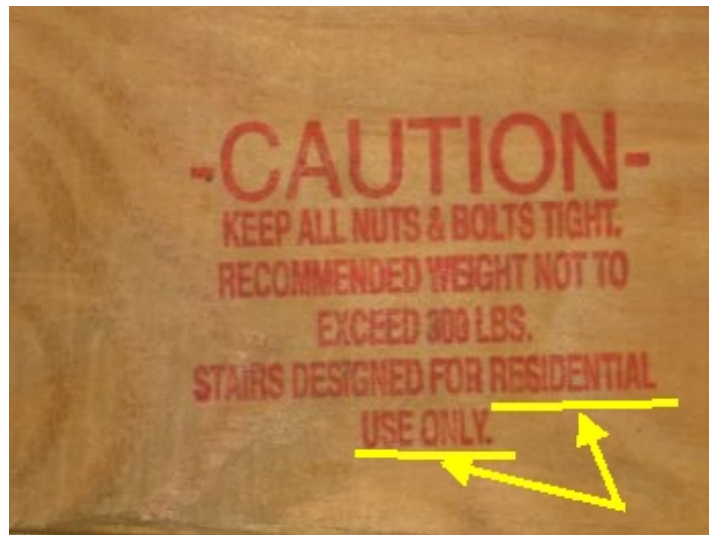
Installed pull down steps are rated RESIDENTIAL ONLY and should not be used in a commercial application. Instructions not followed - The observed installation appears irregular and may not meet the manufacturer installation instructions provided with the item. Refer to the instructions and properly correct installation as needed for safety and function.

Attic steps not rated for commercial use

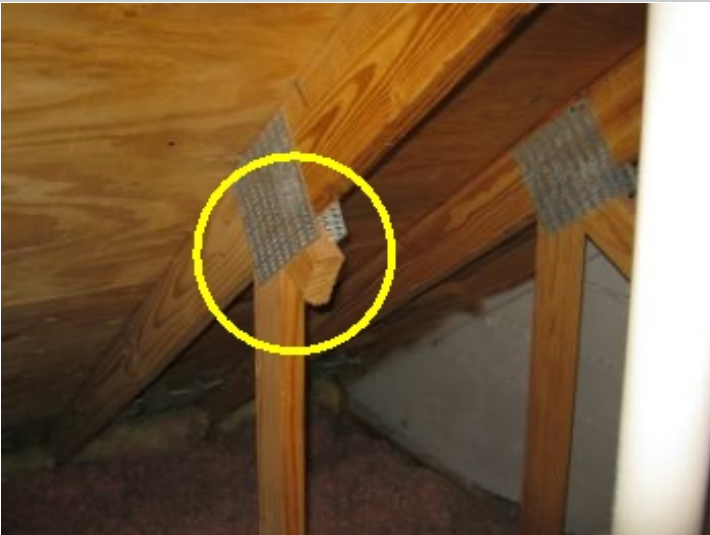
Truss at front furnace appears to be altered and is unrepaired.
Sacrificed Engineered Truss - One or more chords were observed cut at engineered truss. Contact truss manufacturer or other structural engineer to design appropriate corrections. A competent qualified contractor should execute engineering design where needed.

Unrepaired cut truss observed near upstairs furnace for office area

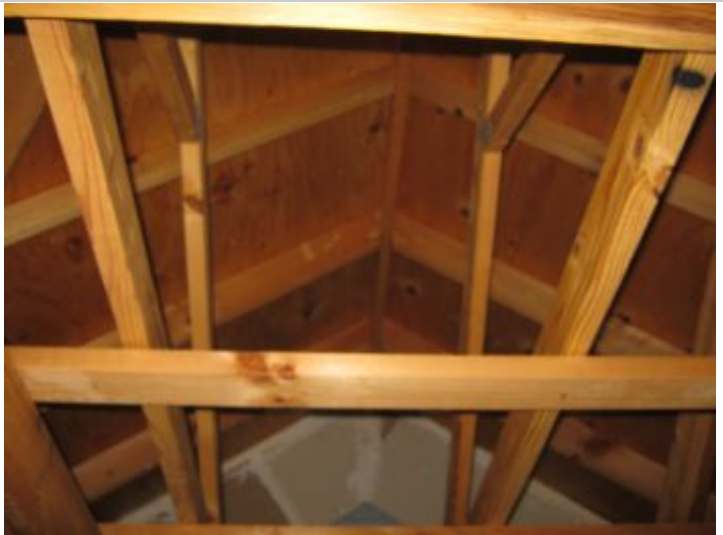
Some roof decking appears missing at trusses of rear addition
Trusses do not appear to be factory designed to support furnaces
Further evaluation roof framing system - Conditions observed at attic framing that warrant further evaluation by a specialist. A structural engineer should further evaluate entire roof framing system and all supports determining corrective measures needed, take action to prevent recurrence and properly repair affected areas where needed.

Some trusses appear to lack sheathing at rear attic area

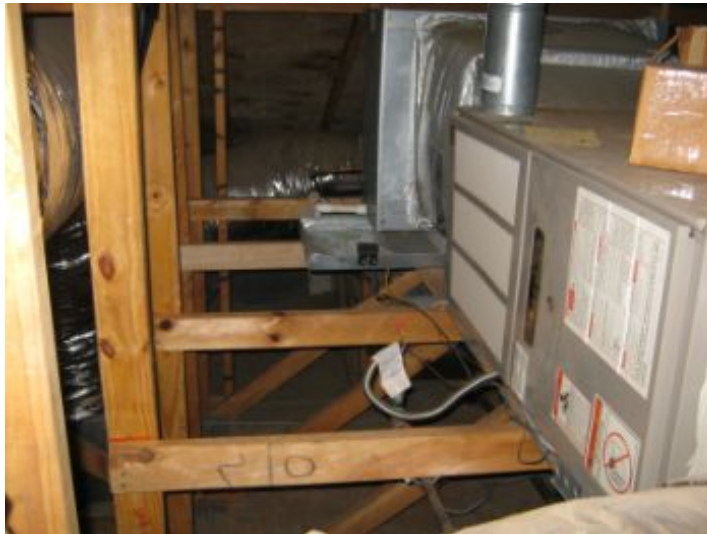
Trusses may not be designed for furnace platform attachment

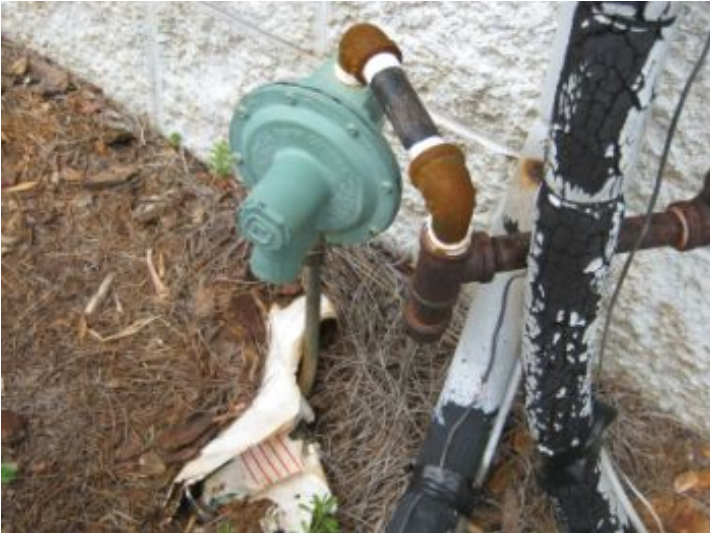
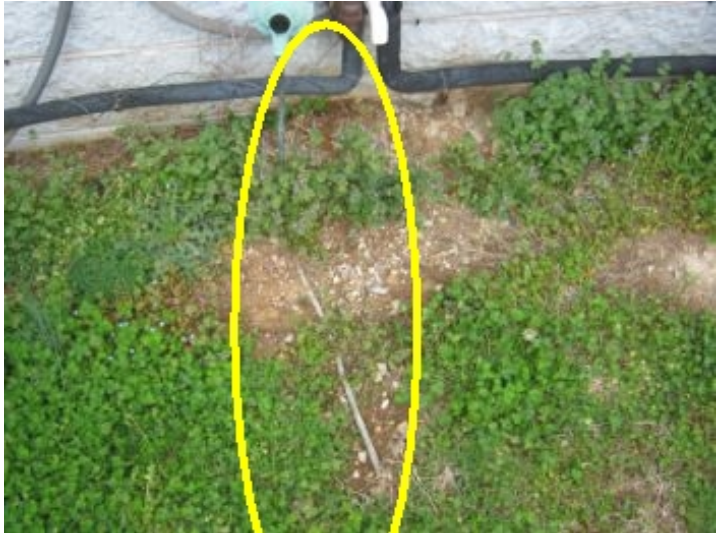
Properly replace gas lines as needed for function and safety
Unprotected gas line - Exterior gas lines should be protected from physical damage to reduce risk of leakage. Correct as needed for safety.

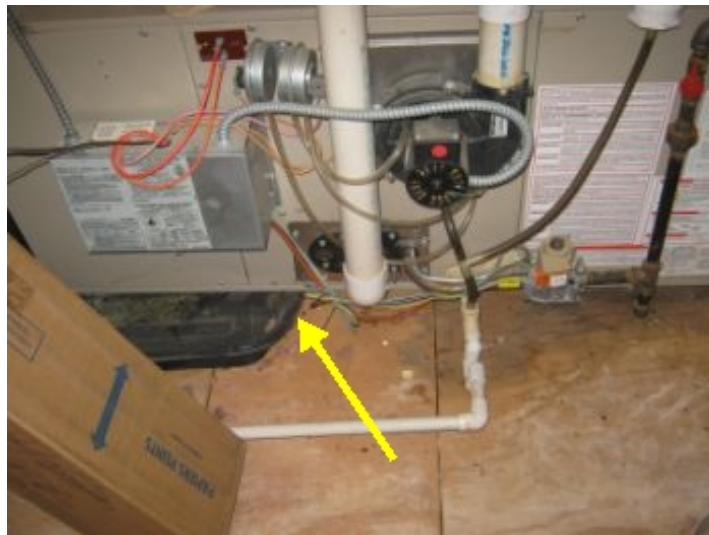
Condensate pan is too small and is damaged beneath upstairs furnace serving upstairs area

Condensate pan missing - Furnaces installed at or above finished living space should have a properly installed condensate overflow pan with separate drain to exterior and/or compressor kill switch. Have qualified competent heat/cool contractor properly correct as needed.

Upstairs office furnace overflow pan damaged and undersized

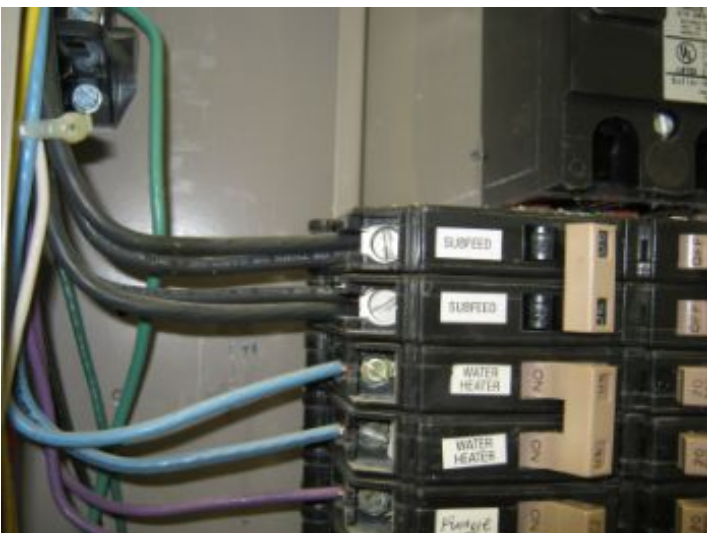
Double tapped breaker - The installed breaker should have only one wire terminate at the breaker terminal. Two wires terminating at a single lug can have a poor connection that may cause overheating or arcing. Proper correction is needed for safety and to protect equipment.

Double tap observed at front sub breaker panel

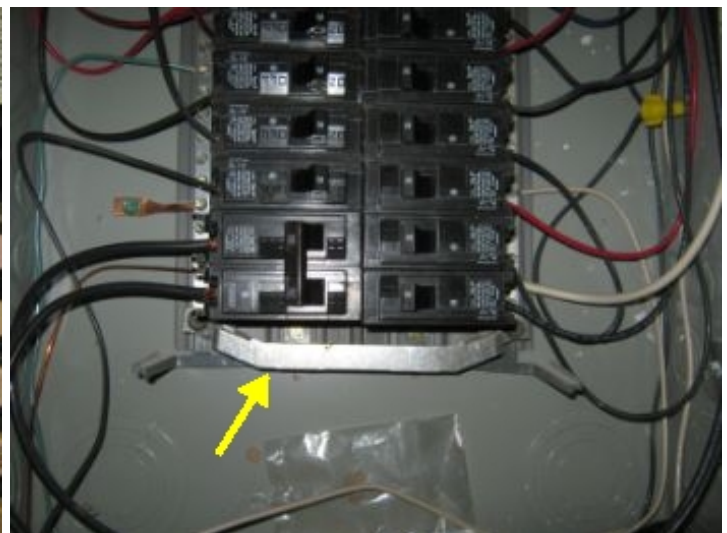
Grounds not isolated - In a sub panel the grounding wires should be isolated from the neutral wires so that a separate redundant path exists between the sub panel and main breaker panel. Have qualified electrician correct as needed.

Grounding and neutral wires are connected at both sub breaker panels, rear sub breaker panel shown in photo

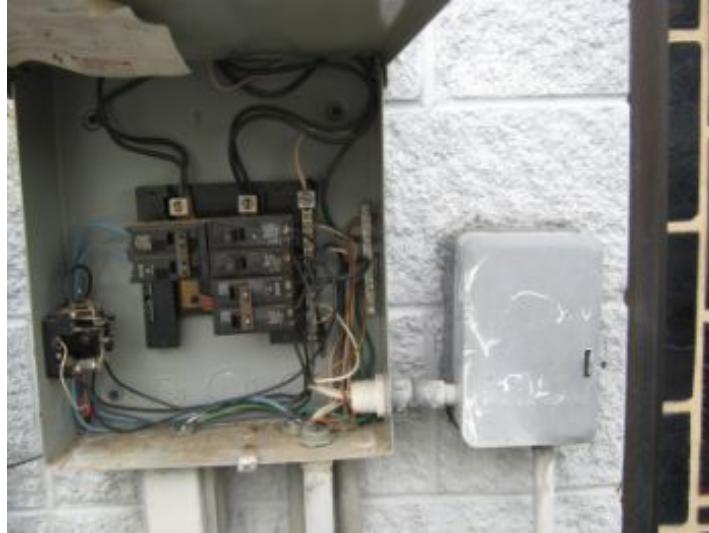
Improper wiring - Improper wiring was noted. Have a qualified electrician check and repair as needed for function and safety.

Improper wiring observed at left exterior AC disconnect panel

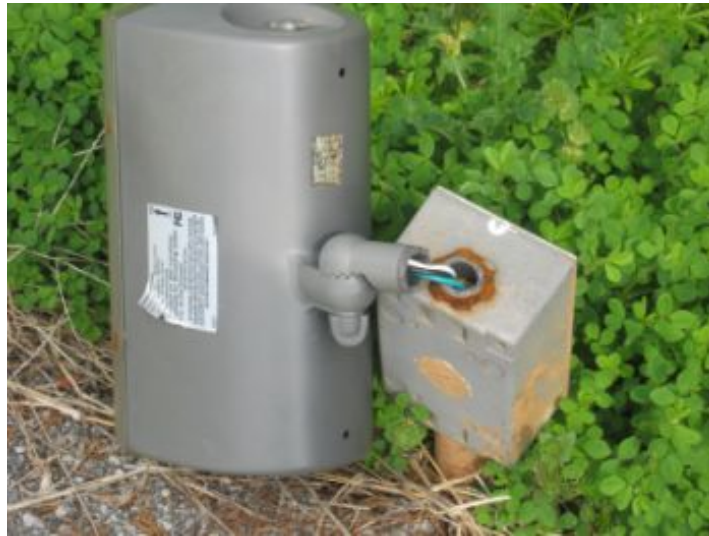
Physical Damage - Physical damage was noted and should be properly repaired.

Damaged exterior lighting

Check all lighting making functional and safe as needed.

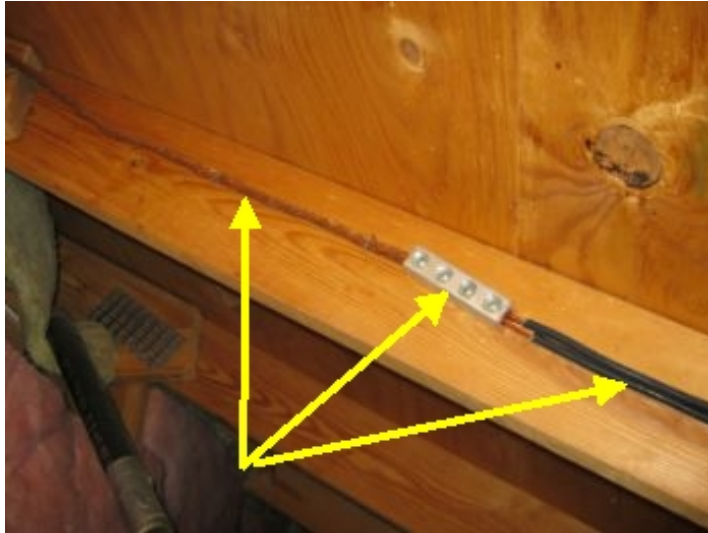
Lightening arrester system is typically installed at exterior of building. Lightening arrester system is questionable. An electrical contractor experienced with this type of installation should further evaluate system correcting as needed for function and safety.

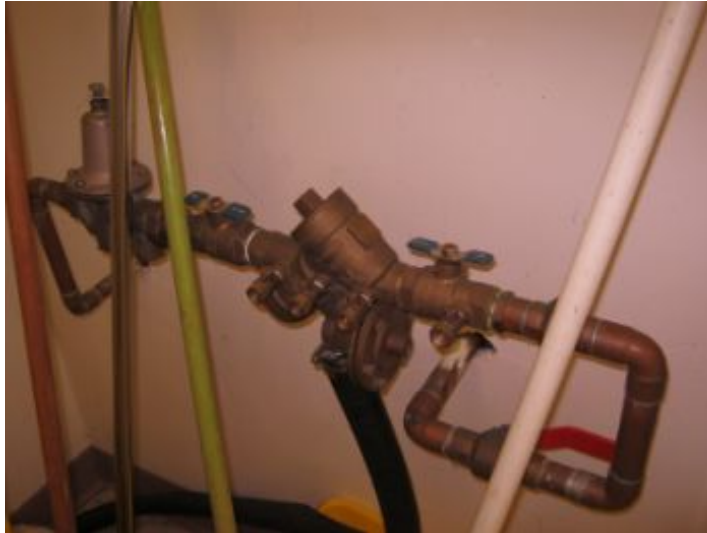
At janitors closet
Back Flow Preventer Observed - Contact water utility to verify procedures required for annual testing and report compliance to ensure safe drinking water.

Back flow preventers require annual testing and reporting

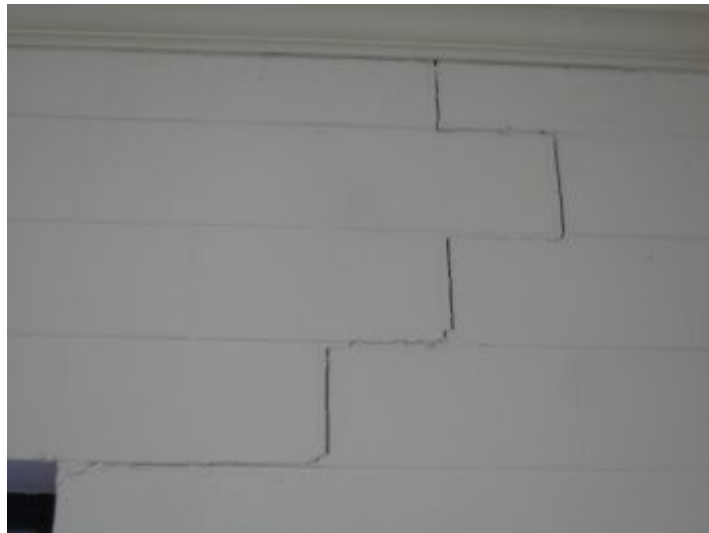
Cracks from expansion or settlement - Noticeable cracking was observed. This is not unusual. Monitor and properly repair as needed.

Monitor settlement cracks

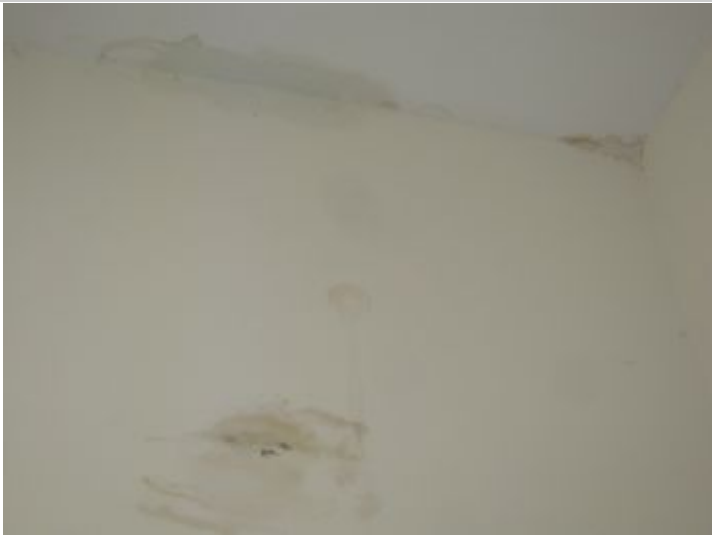
Stained - The material is stained. Some stains may be very difficult to remove. Before repairing, be sure the source of the stain has been located and cured.

Ceiling and wall stains observed

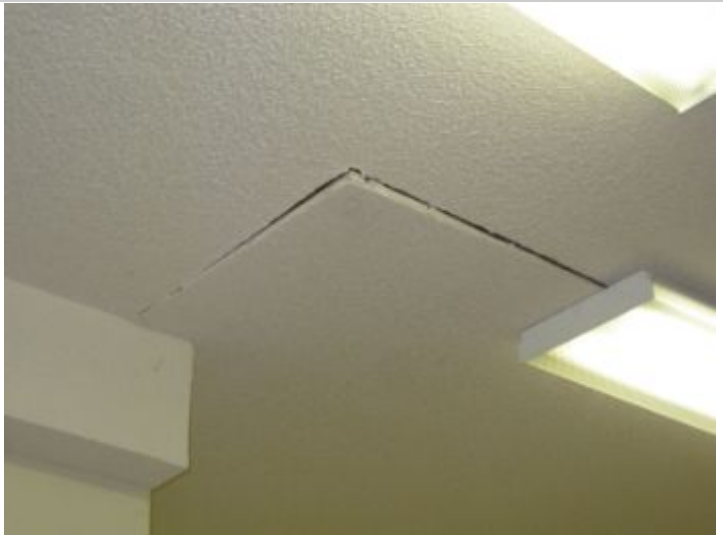
Physical damage was noted and should be properly repaired.

Damaged ceiling ready for correction at rear
