PROPERTY INSPECTION REPORT

New but inspected after moving in
Inspection prepared for: Builder Warranty
Inspection Date: 4/1/2011 Time: 8:30 AM
Age: Built 2010
Weather: Overcast

Inspector: Roger Williamson
License # 226 TN - ASHI Certified Member # 204213 - Proud Member BBB
2409 Haven Crest Dr, Chattanooga, TN, 37421
Phone: 423-421-4913
Email: HomeProInspection@EPBFI.com
www.HomeProInspection.com

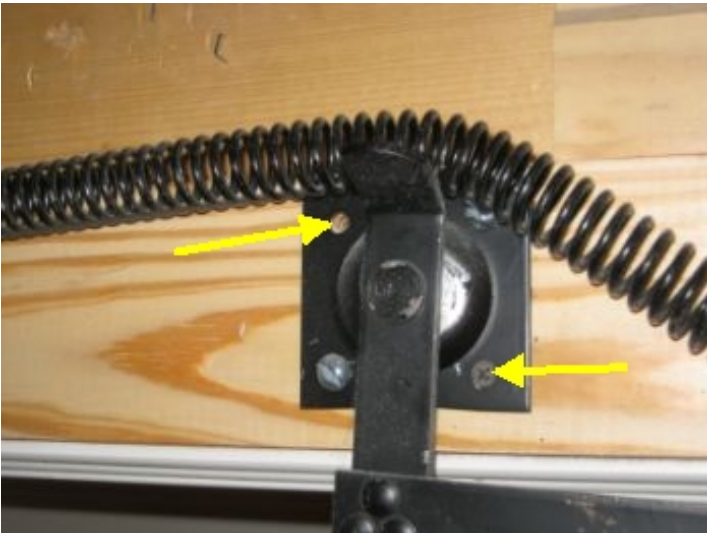
Pull down stair nails - Attic pull down steps are missing required 16d nails at metal spring arm pivot plates and corner brackets near the piano hinge. These should be properly nailed for safety. Refer to installation instructions and correct as needed.

Spring Arm Pivot Plate - Small screw shown at right arrow where nail is required, nail missing at left arrow where opening is visible

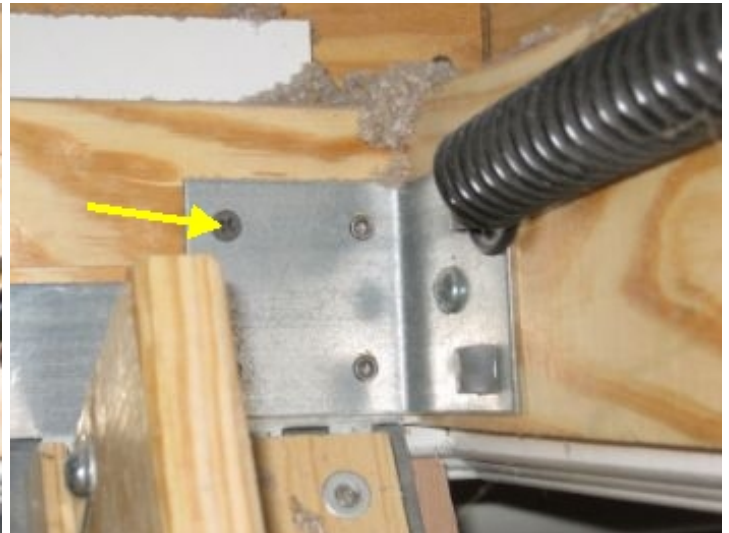
Pull down stair small screws - Small screws should not be used to attach pull down attic steps to structural framing. Typical instructions require 16d nails or 1/4" diameter three inch long lag screws. A competent contractor should refer to instructions and correct for safety and to prevent collapse of attic steps.

Corner Bracket has small screw installed where nail is required

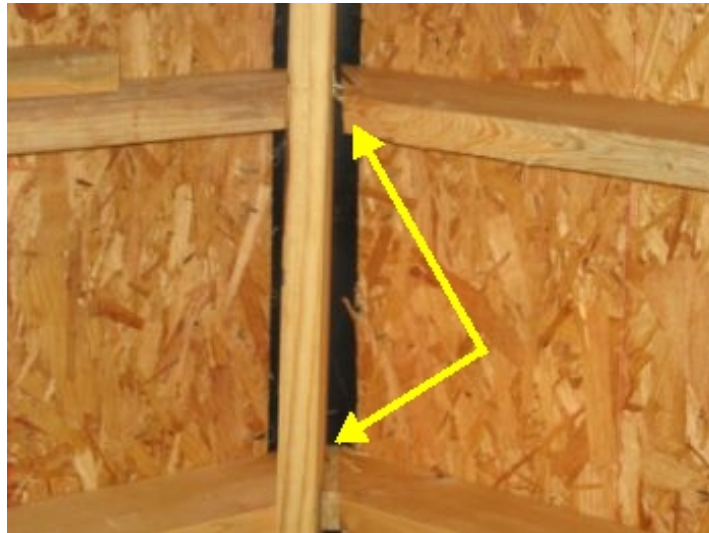
Some roof rafters have large open gaps where rafter should meet ridge board. Some rafters have shims between rafters and ridge board. Since home is nearly new construction the inspector recommends installing sister rafters of no less than six foot in length at all areas where rafters have gaps or have shims to prevent unwanted settlement. Use proper size and quantity nails in a staggered pattern to properly share load of original rafter and sister rafter.

Top arrow shows large gap where rafter should meet ridge board, lower arrow shows shim where rafter should meet ridge board

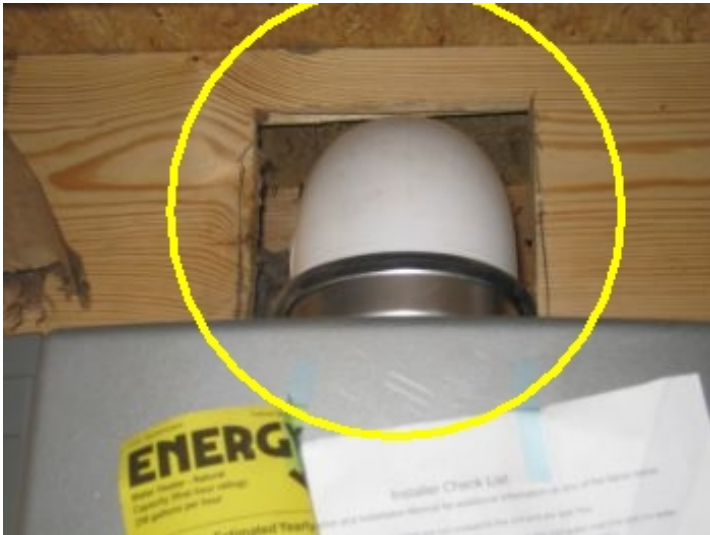
Observed at floor joist sacrificed for water heater flue
Sacrificed Floor Framing - Wood framing noted sacrificed in area listed. Usually this is to accommodate plumbing, electrical or heat/air installation. Area viewed has not been properly braced to restore strength of framing sacrificed.
Additional repair is recommended.

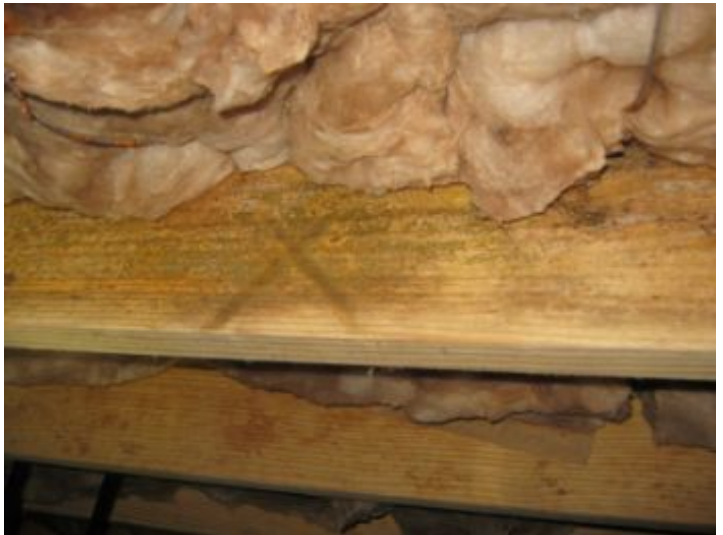
Suspect fungi observed - The inspector recommends further evaluation by a specialist properly correcting as needed. The presence of fungus is typically a secondary condition being the result of an excess moisture condition in the area. The first step in correcting a fungus condition is to determine the source of moisture and eliminate it, if possible.

Suspect fungus in crawl space near rear patio, X drawn to shown surface growth rather than staining at floor joist

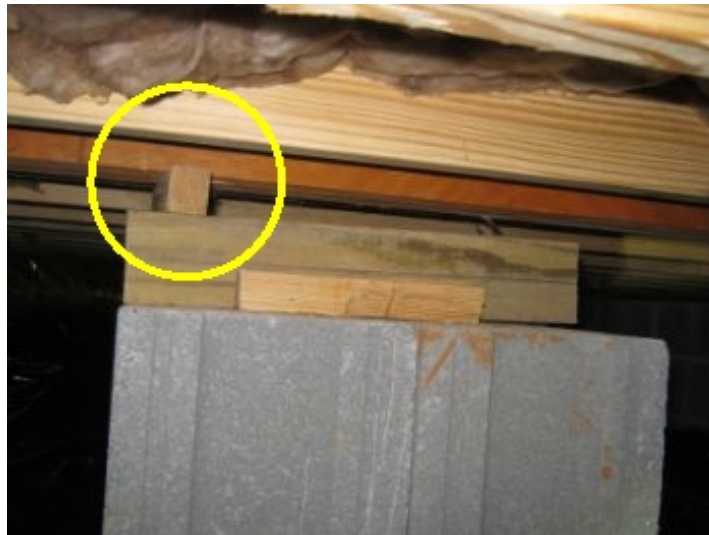
Concrete Block - verify with house plans whether proper shims should be added at lam beam beneath exercise room or if temporary shims should be removed.

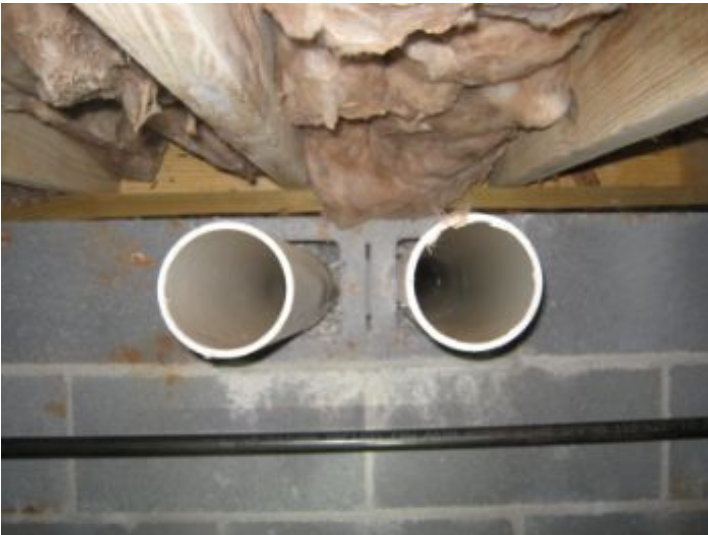
Rear crawl space vent at patio has been abandoned and suspect fungus was observed. Some crawl space vents are obstructed by concrete block and can not function. Properly correct crawl space ventilation as needed to protect structure.

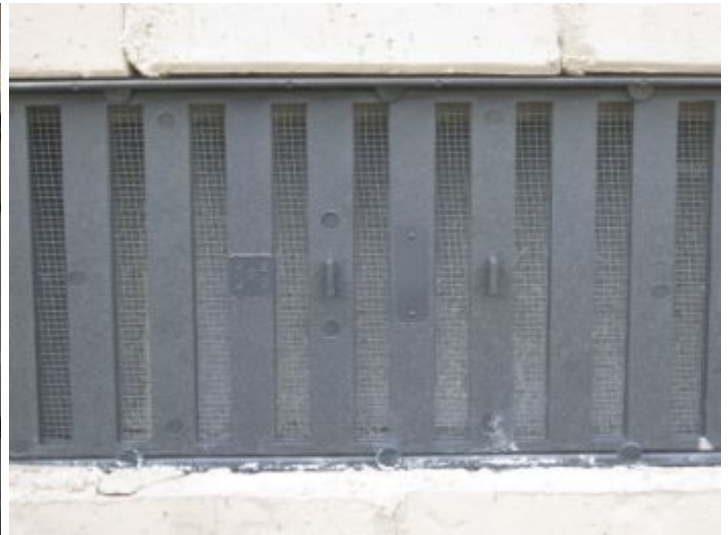
Concrete block prevents air flow into crawl space at foundation vent

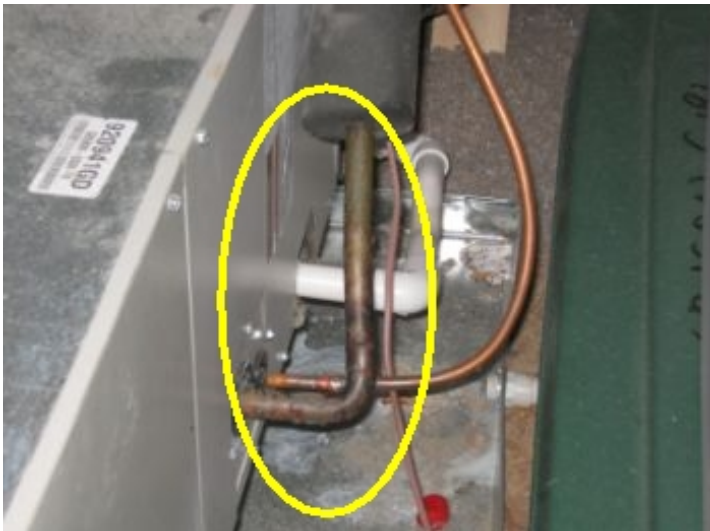
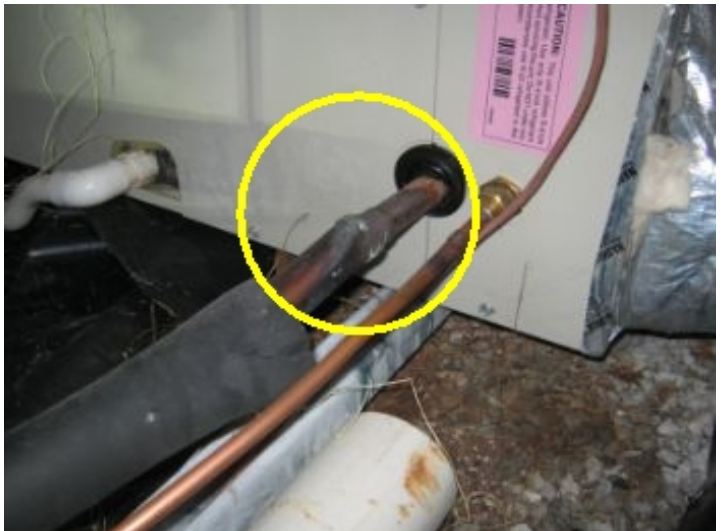
Cooling system refrigerant lines need insulation - Sections of the insulation on the compressor lines appear to be missing. These lines should be suitably insulated for the proper operation of the compressor.

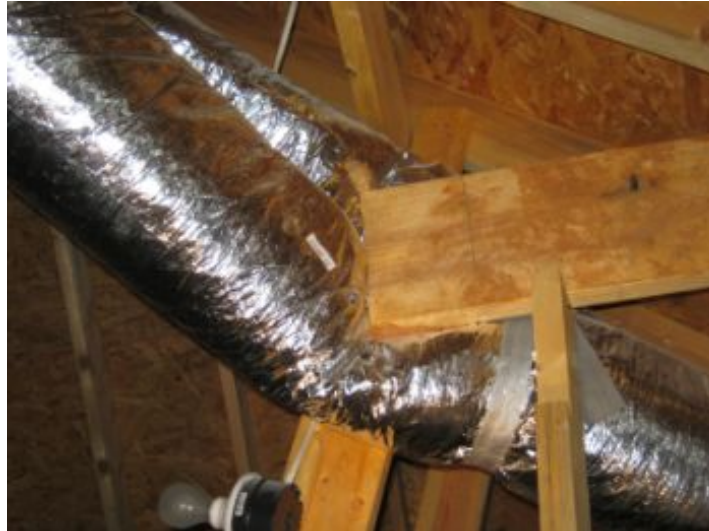
Flex duct in a bind - Flexible heating/cooling duct mashed or bound at turn. Flexible duct should be installed to allow free air flow and turns in flex duct require sufficient radius in duct to maintain air flow. Correct as needed.

Flex duct observed in a bind in attic

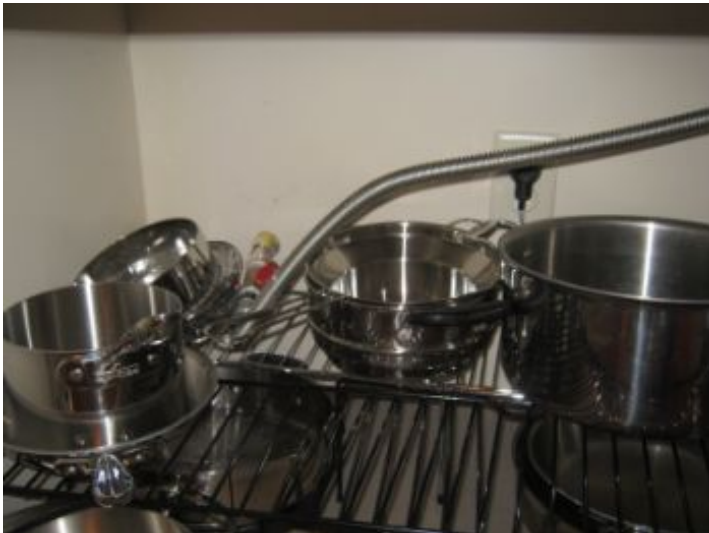
Gas piping beneath range does not appear to be properly protected from physical damage

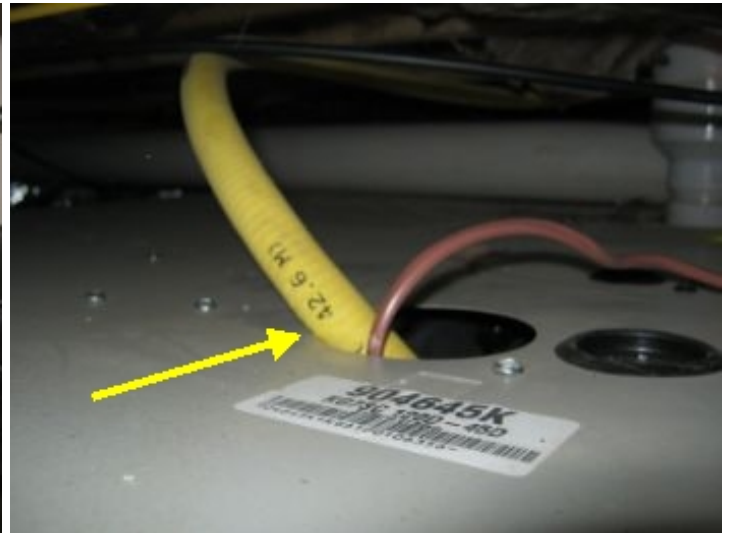
Gas piping not protected from physical damage at furnace

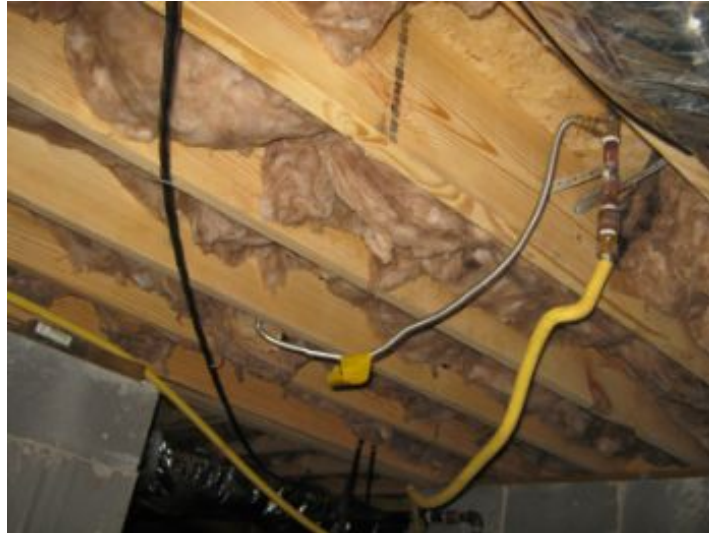
Questionable gas piping - A competent qualified pipe fitter should review the gas piping installation correcting where needed for function or safety.

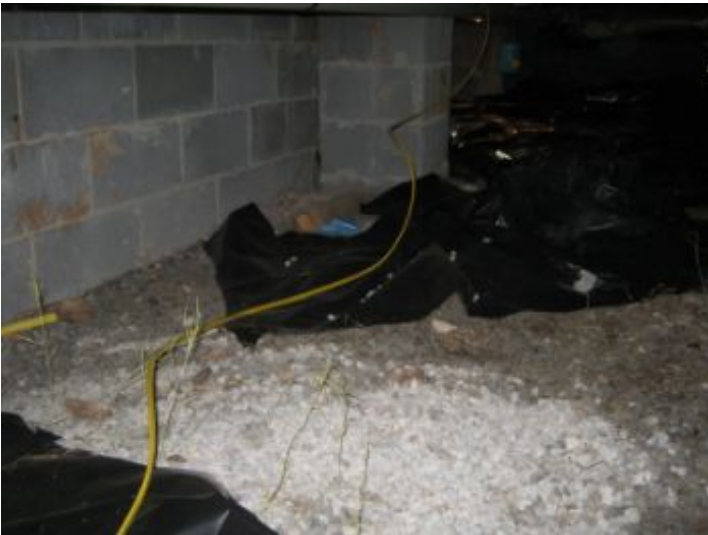
Wiring in crawl space is dangling and should be properly fastened in place to protect wiring from physical damage.

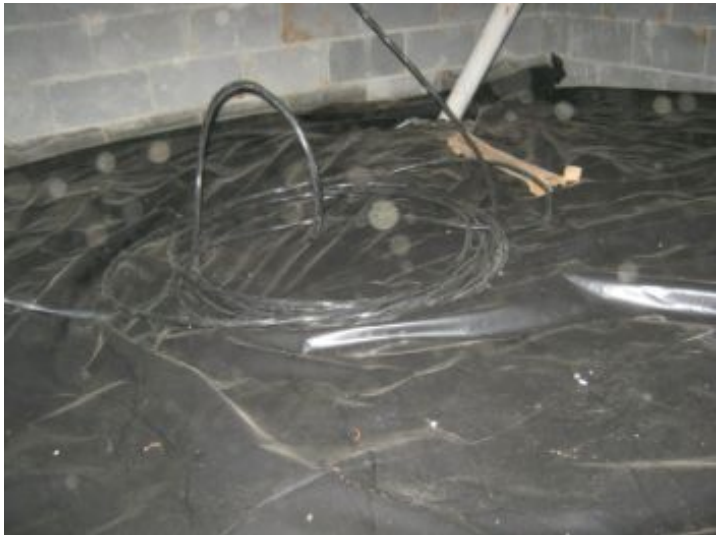
Unterminated wiring - Some wires viewed not terminated. Add wire nuts to all unterminated wiring in junction boxes/panel or otherwise properly terminate in junction box with cover as needed.

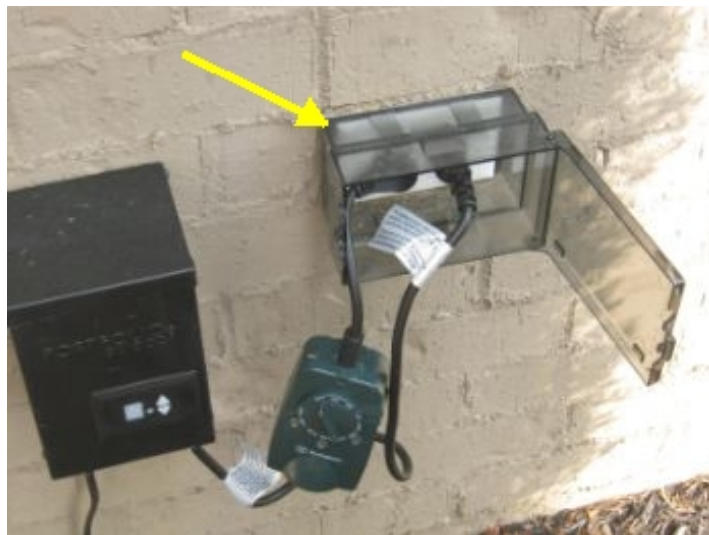
Periodic Maintenance Needed- Install proper continuous use cover at rear exterior receptacle

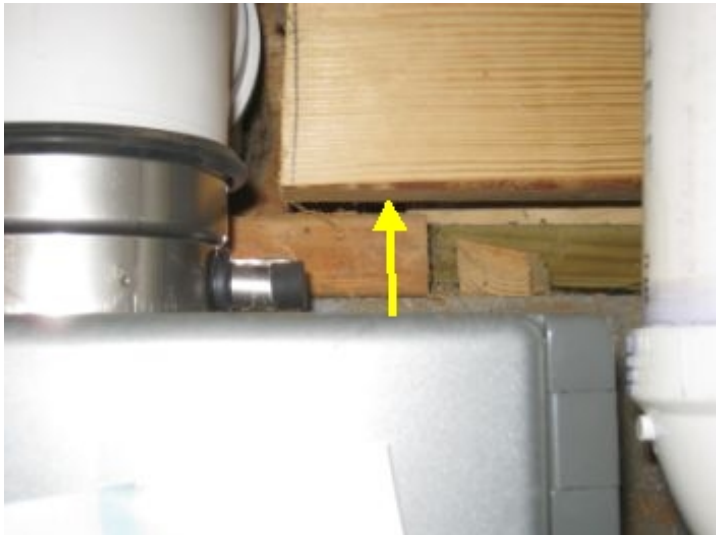
Water heater does not appear to have proper clearance from combustibles as wooden floor joists are less than six inches above water heater. Crawl space installation may not meet indoor installation requirement from manufacturer. Questionable installation - Water heater may not be installed correctly. Refer to installation instructions and have a competent contractor correct as needed for function and safety.

Water heater does not have proper clearance from combustibles as noted in installation instructions

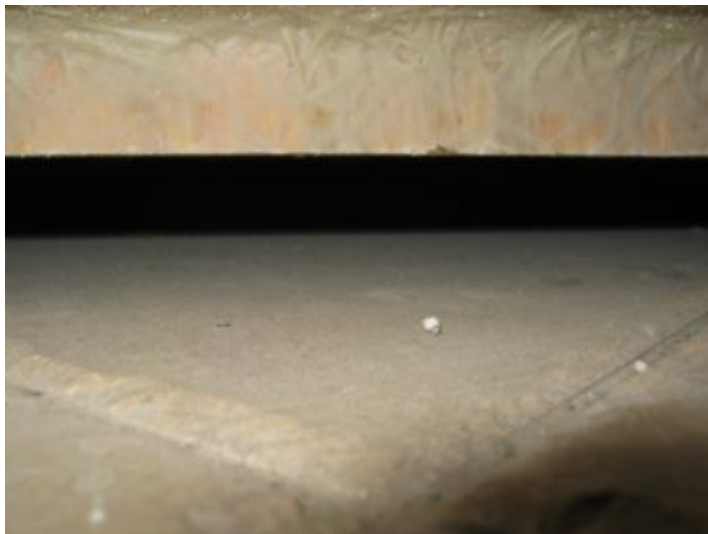
LOCATION: Master Bath

Unsupported Tub - Floor of tub does not appear to be properly supported and tub may be suspended by tub rim only. Check tub installation instructions and properly correct as needed.
